BURNING MAN 2023 POST EVENT INSPECTION REPORT

Bureau of Land Management, Winnemucca District

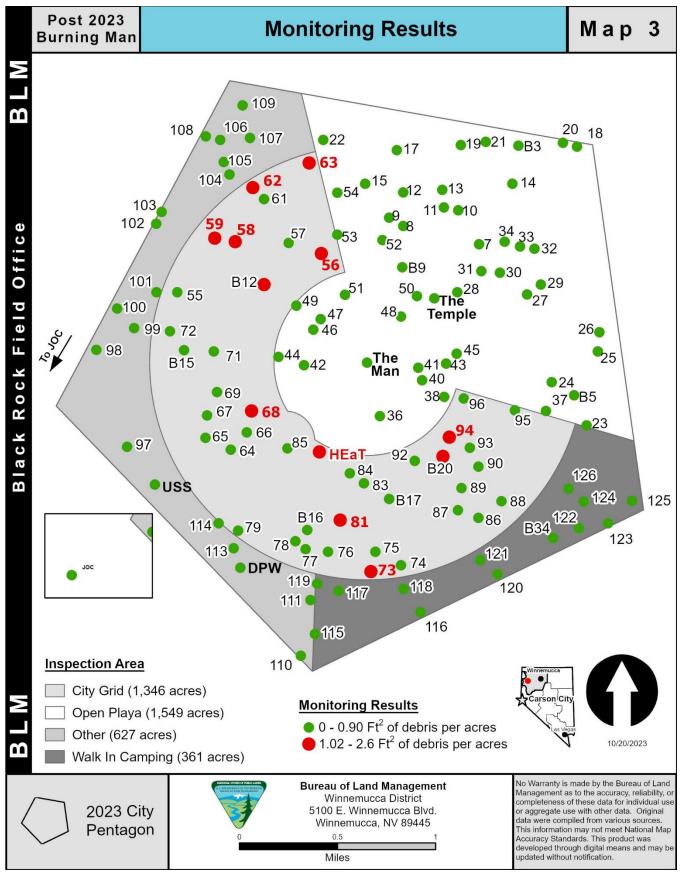
Appendix B lists all inspections sites and area calculations. Map 3 displays the locations of sites exceeding the standard.

The 2023 PEI results show that of the 42 monitoring sites within City Grid, 11 sites exceed the 1ft²/acre standard.

The 2019 Post Event Report recommended that the POIs be considered in the overall statistics. However, this was not specified in the 2023 protocol and therefore will not be included in the overall calculation for the 2023 event. The 2023 results show only HEaT did not meet the $1ft^2$ /acre standard, having $1.02 ft^2$ /acre of debris.

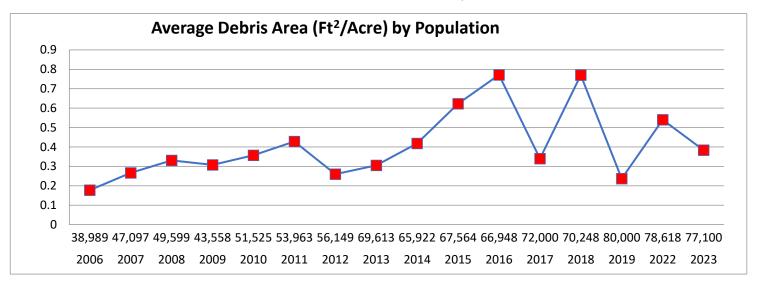
Figure 2 Debris Area by Population

In 2023, the Burning Man Restoration crew was able to reduce the debris area average by roughly 25% from the 2022 average. While the BLM realizes the Event had a decrease in attendance of around 2% from the 2022 Event, the sloppy conditions created by the unexpected rain created more challenges in the cleaning of the playa after the 2023 Event.

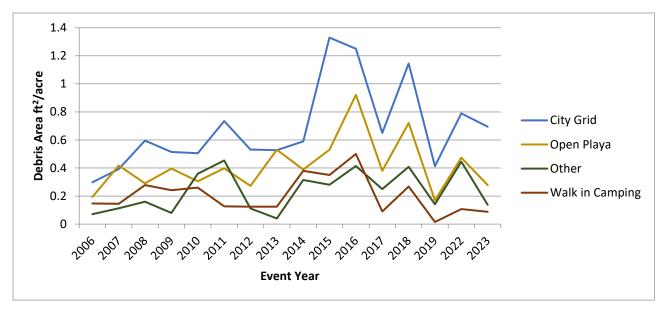
Figure 4 Average Debris Area by Inspection

The City Grid continues to be an area of concern. Twenty-five percent of the sites in City Grid exceeded the standard, whereas none of the sites in the remaining Core Inspection Areas exceeded the threshold. HEaT exceeded the standard for the 2023 event and is also located in the City Grid.
